Light Movement, an art installation by Alan Smith

Effect delivered by the "Kinelume" designed by

J.H. Paterson. Circa 1975

Renovation by Gary Morgan 2016

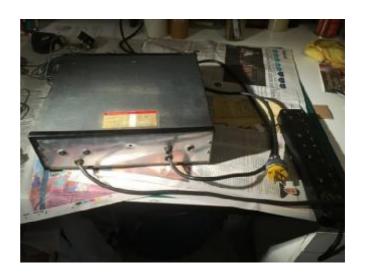
Immediately the mains wiring gave cause for concern and when powered up, occasionally the office RCB tripped indicating earth leakage issues. This was hardly surprising given that that mains suppression inductors were burnt out.

So these issues were addressed. There was a compromise of trying to keep the unit faithful to its original build or make it safe. The latter won over, with a new mains filter being installed together with a proper plug and switch arrangement for the power cables.

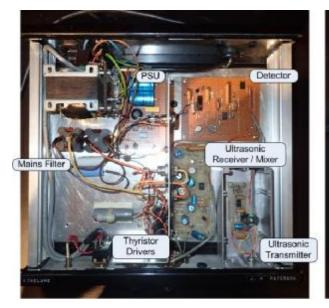
Looking at the brightness issue I found that only one of the output thyristors was firing so the lamp was only ever getting a half wave output. Digging around I found dry joints to a DC blocking tantalum capacitor on driver board, correcting this gave a brighter light.

My probing also found that the supply was very noisy so I set about replacing old electrolytic capacitors and adding decoupling capacitors. This made the supply very much more stable.

As the "Kinelume" is analogue there were a lot of preset potentiometer's, the setting and effects of which were not known. Their intial positions were noted. Then out with the oscilloscope to investigate and calibrate. A lot of time was spent playing and adjusting while watching what was going on. This resulted in much better performance of the unit and I was able to document the setup of the unit.

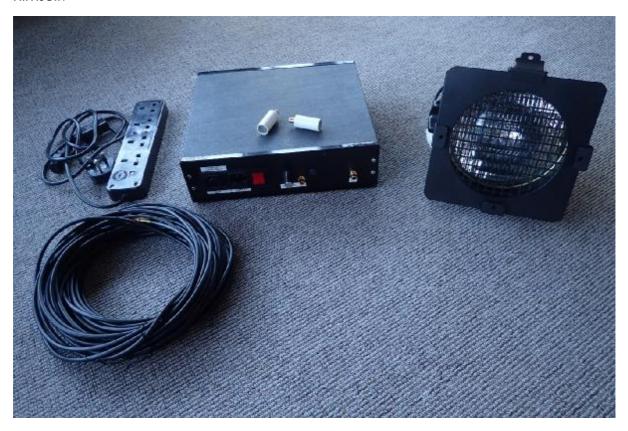
- Poor Earthing
- Earth leakage
- Mains Input & Output Connections
- Strain relief to Mains Cables
- Inductors burnt out

- Transformer outputs transposed and do not provide the voltages indicated.
- Input fuse rated at 5A
- No load transformer outputs: 2 x 0V, 13.6V & 27.3VAC 0.5A,

Note: A couple of the output pins have been miss-wired internally and so do not deliver the voltages marked up.

- Securely fixed base plate to chassis to prevent broken connections
- Securely fixed transmitter housing to baseplate
- Lubricated Sensitivity Potentiometer
- Glued broken front bezel
- Remade 12Vac connection from transformer to power supply PCB
- Remade RX connection from front panel to preamp PCB
- Photographed unit
- Sourced alternative ultrasonic transducers to the original EFR-OAB40K4 & EFR-RAB40K4 units that were damaged or lost. Replaced with Pro-Wave 400ST160 & 400SR160.
- Powered up on 110V transformer and took initial PSU readings with outputs disconnected. ±10V
- Rewired transformer for 240V operation

- Rewired power supply lines to PCBs to minimise noise & earth loops etc.
- Rewired mains wiring
- Added smoothing and decoupling capacitors to all circuit boards to reduce noise and ripple
- Installed IEC plug & socket to front panel to provide better safety and cable management.
- Replaced snubber circuit
- Replaced mains input chokes to provide better RFI protection
- Installed a single point earth.
- Replaced key capacitors to PSU and ultrasonic pre-amp
- Replaced ultrasonic transducers and re housed
- Removed unnecessary component's from external panels
- Replaced capacitor on driver board providing much better performance
- Recalibrated unit & documented
