Light Movement, an art installation by Alan Smith

Effect delivered by the "Kinelume" designed by

J.H. Paterson. Circa 1975

Renovation by Gary Morgan 2016

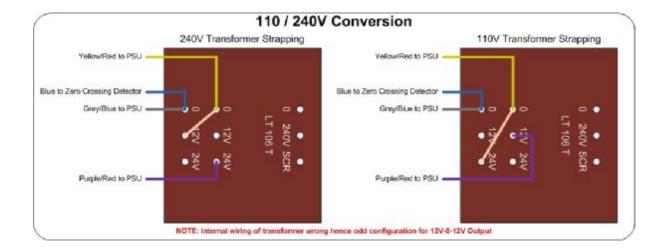
- Transformer outputs transposed and do not provide the voltages indicated.
- Input fuse rated at 5A
- No load transformer outputs: 2 x 0V, 13.6V & 27.3VAC 0.5A,

Note: A couple of the output pins have been miss-wired internally and so do not deliver the voltages marked up.
